Water Quality Assessment Report

Saddler Creek

Huntingdon County, Pennsylvania

Huntingdon County Conservation District

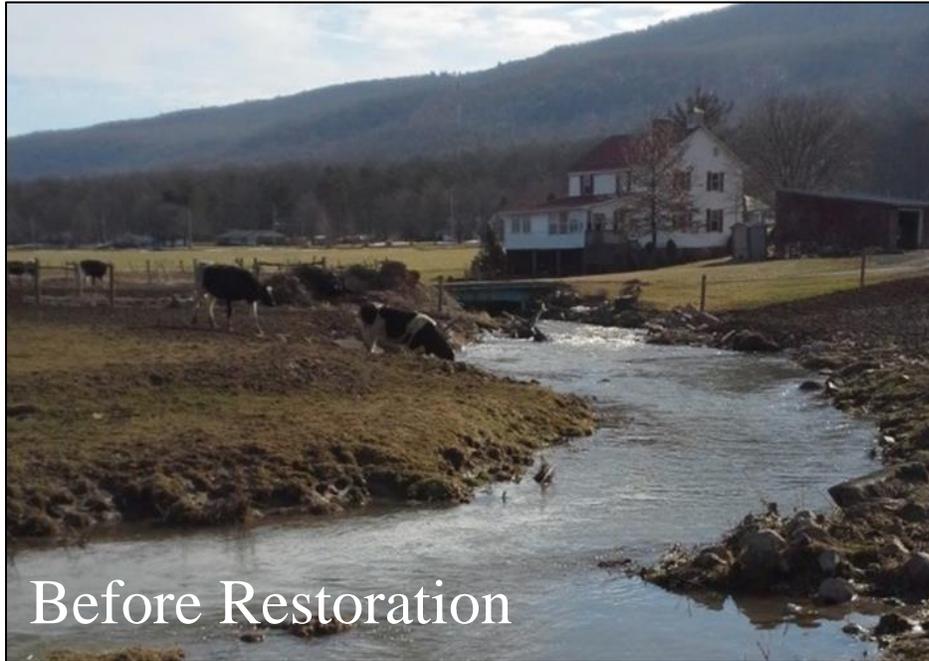
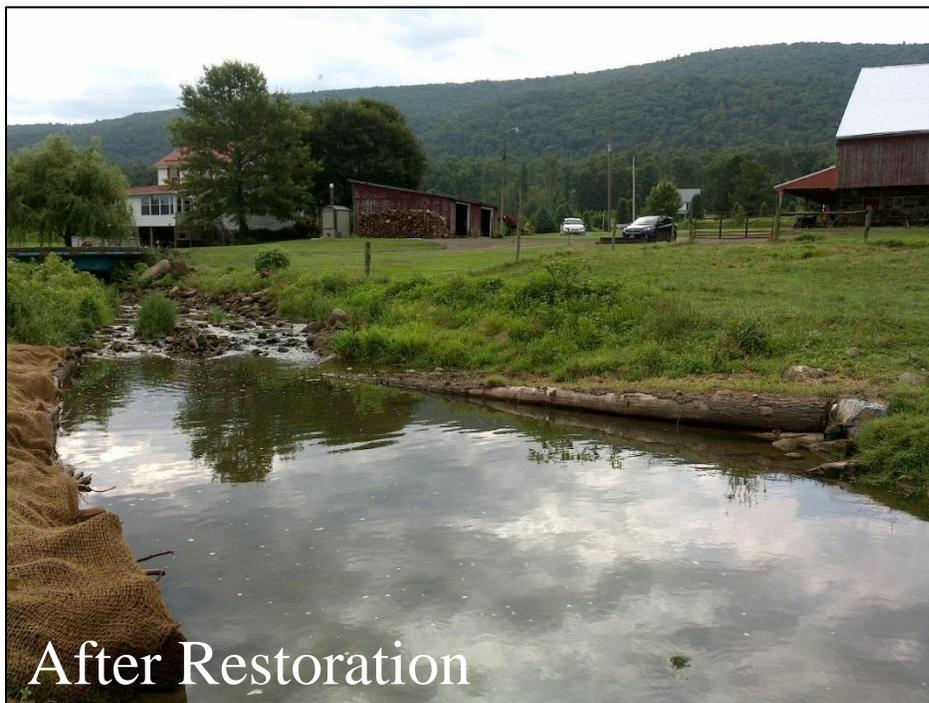
Photos 3-4. An example of some of the in-stream restoration work completed at several properties along Saddler Creek.

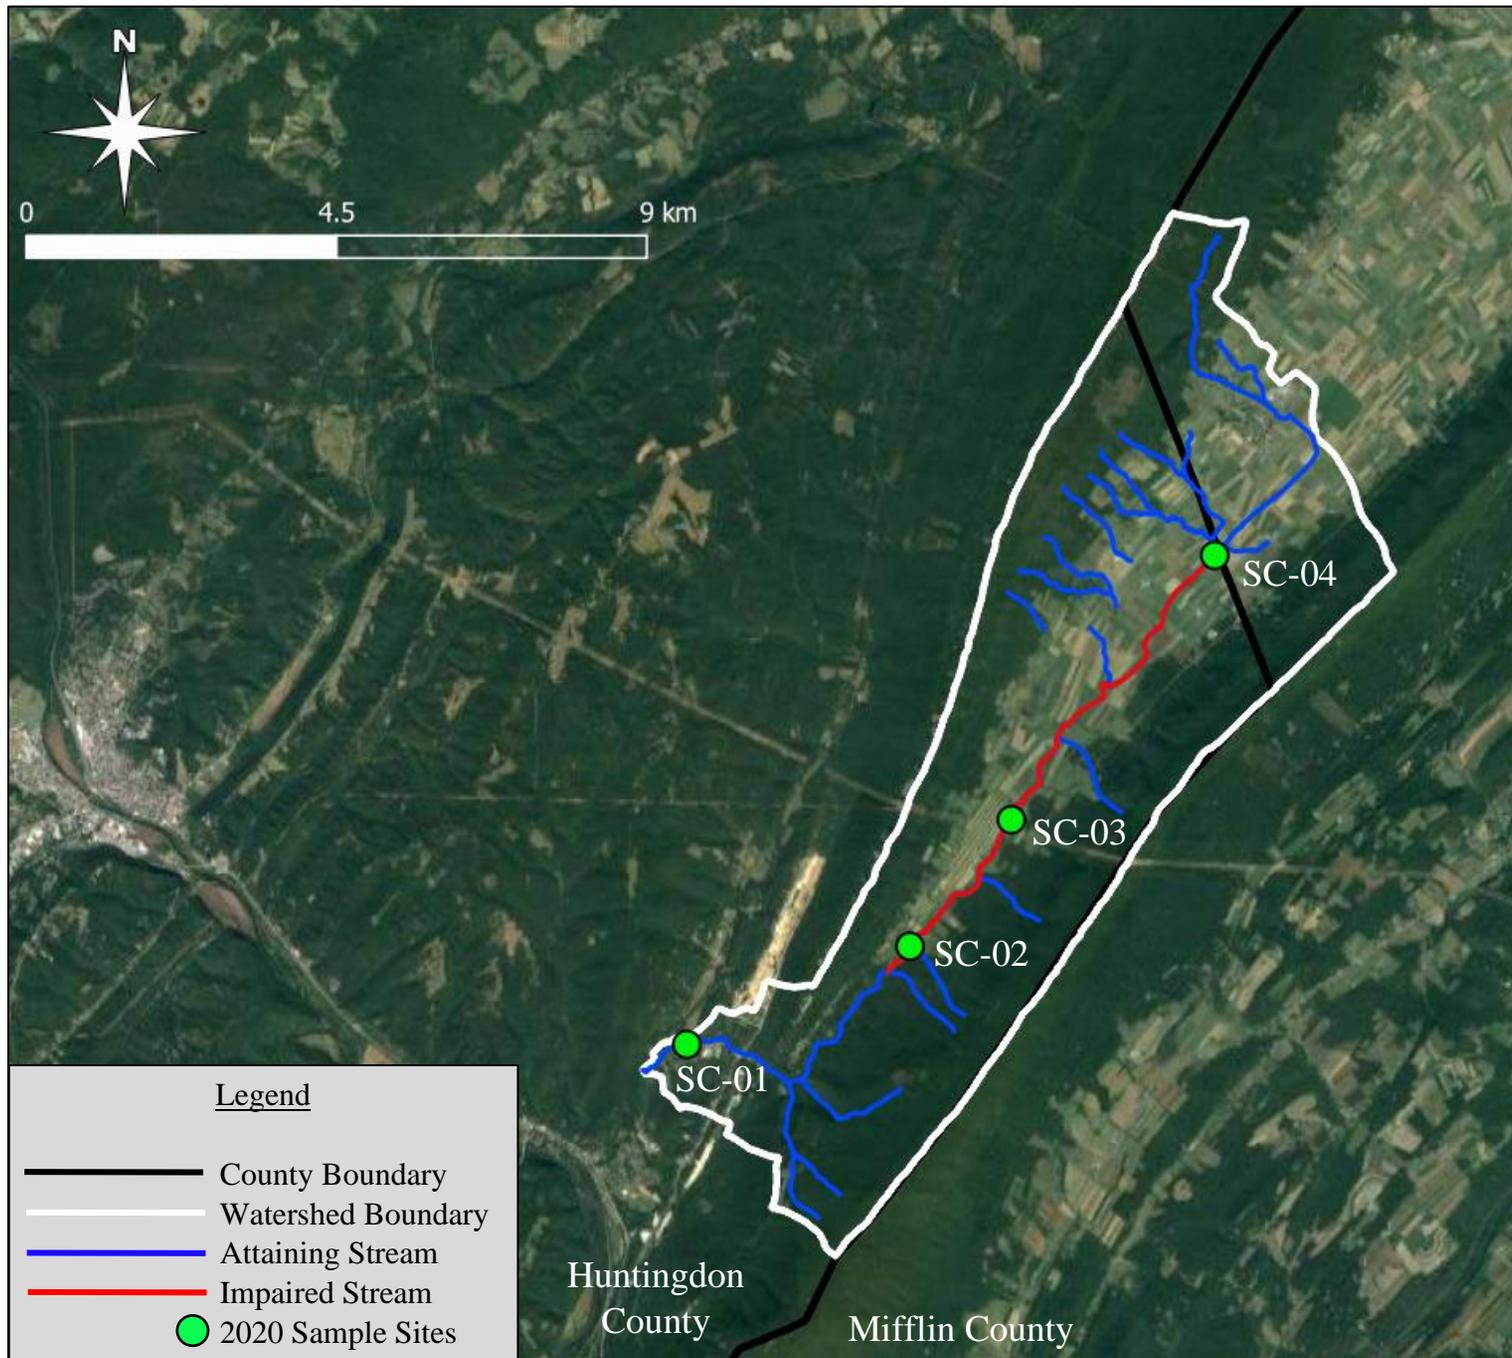
Figure 1. Map of 2020 sample sites in the Saddler Creek watershed.

To accurately provide a snapshot analysis of the entire watershed’s current health, a total of four sites were selected throughout the Saddler Creek watershed (Figure 1). Specifically, one site was selected on the downstream “attaining” reach while the other three sites were sampled along the “impaired” reach of Saddler Creek. Water chemistry, physical habitat, and benthic macroinvertebrates were all measured at each study site.

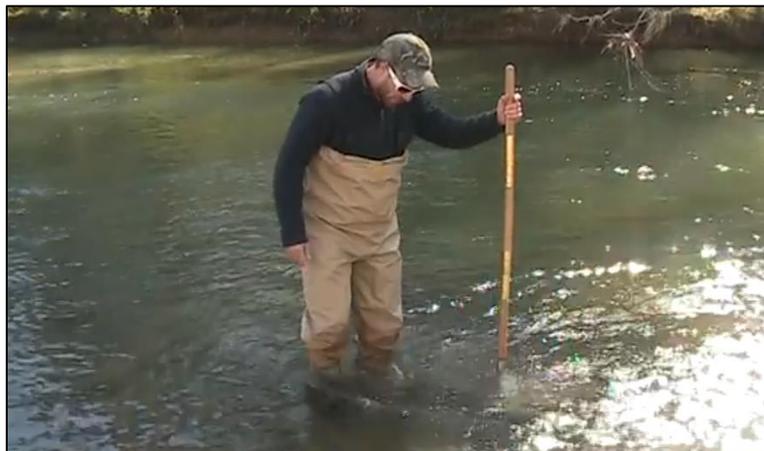
Photo 5. HCCD Watershed Specialist collecting a benthic macroinvertebrate sample.

Benthic macroinvertebrate samples were collected at each sample site following PADEP methodology for wadeable, freestone, riffle-run streams

(Shull and Lookenbill 2018). Collection begins by delineating a 100-meter reach along the stream of interest. A six-kick composite sample is collected from the reach using a 12-inch wide x 10-inch high D-frame net with 500-micron mesh. For each kick, the collector places the net against the stream bottom and disturbs a one square meter area immediately upstream of the net for approximately one minute. The collector attempts to distribute the kicks among a variety of riffle habitats (e.g., slow-flowing, shallow riffles and fast-flowing, deeper riffles). Kicks were also conducted throughout the width of the stream to include the left, middle, and right areas. This is done to ensure the composited sample provides an accurate representation of the macroinvertebrate community throughout the stream reach.

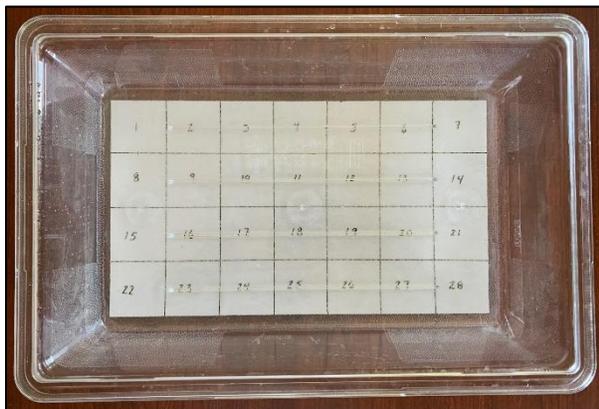
Photo 6. Example of gridded subsampling pan.

In the laboratory, benthic macroinvertebrate samples were sorted and processed following PADEP methodology for macroinvertebrate samples collected from freestone streams (Shull and Lookenbill 2018). Prior to subsampling, the composited sample is removed from the collection container and placed in a 500-micron sieve. The sample is gently rinsed under running water to remove ethanol and minimize damage to the macroinvertebrates. The sample is then placed in an 18-inch x 12-inch x 3½-inch pan, marked off into (28) 2-inch x 2-inch grids. Water is added to the pan before sample placement to ensure the macroinvertebrates are evenly distributed throughout the pan, and to prevent the contents of the sample from drying out during the subsampling process. Once the contents of the sample are placed in the pan, four 2-inch x 2-inch grids are randomly selected.

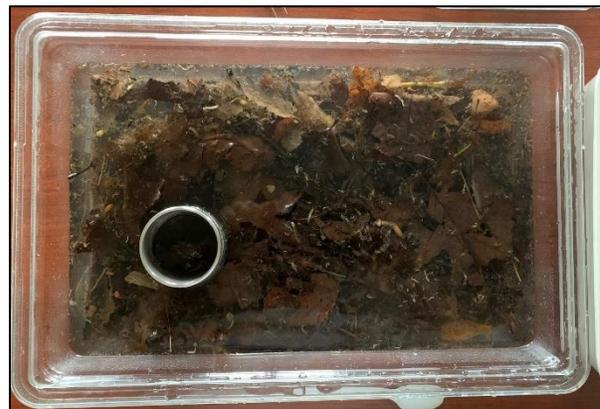
Photo 7. Subsampling pan with sample contents and one “cookie cutter” grid selected.

The materials and organisms from the selected grids are removed from within four-square inch circular “cookie cutters” placed in the randomly selected grids and removed using spoons, turkey basters, tweezers, and other implements as needed. The extracted contents are then placed into a second pan with water. Identifiable organisms are then picked and counted from the second pan.

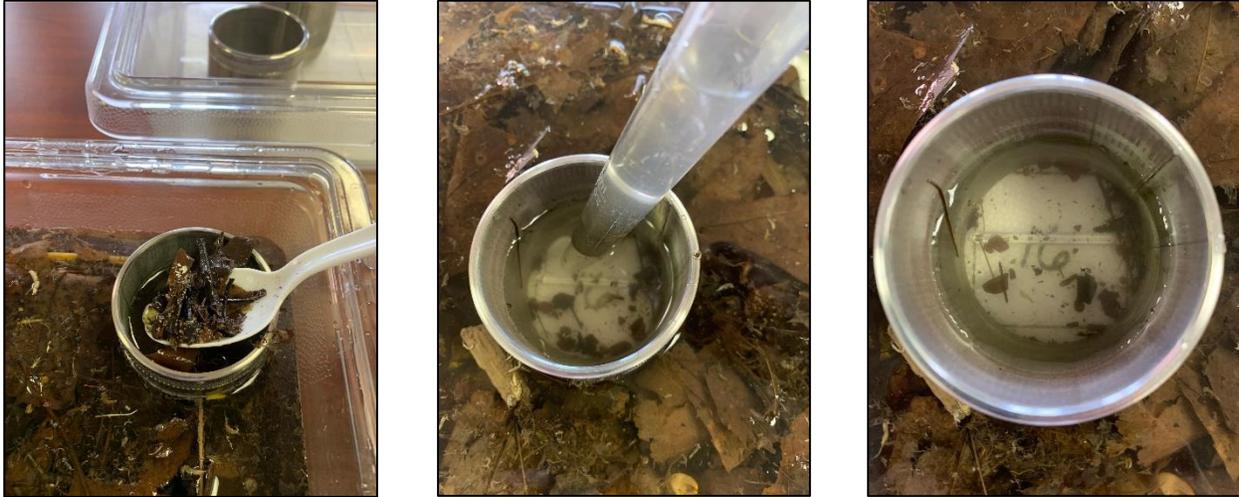
Photos 8-10. Contents of the subsampling grid are removed using spoons, turkey basters, etc.

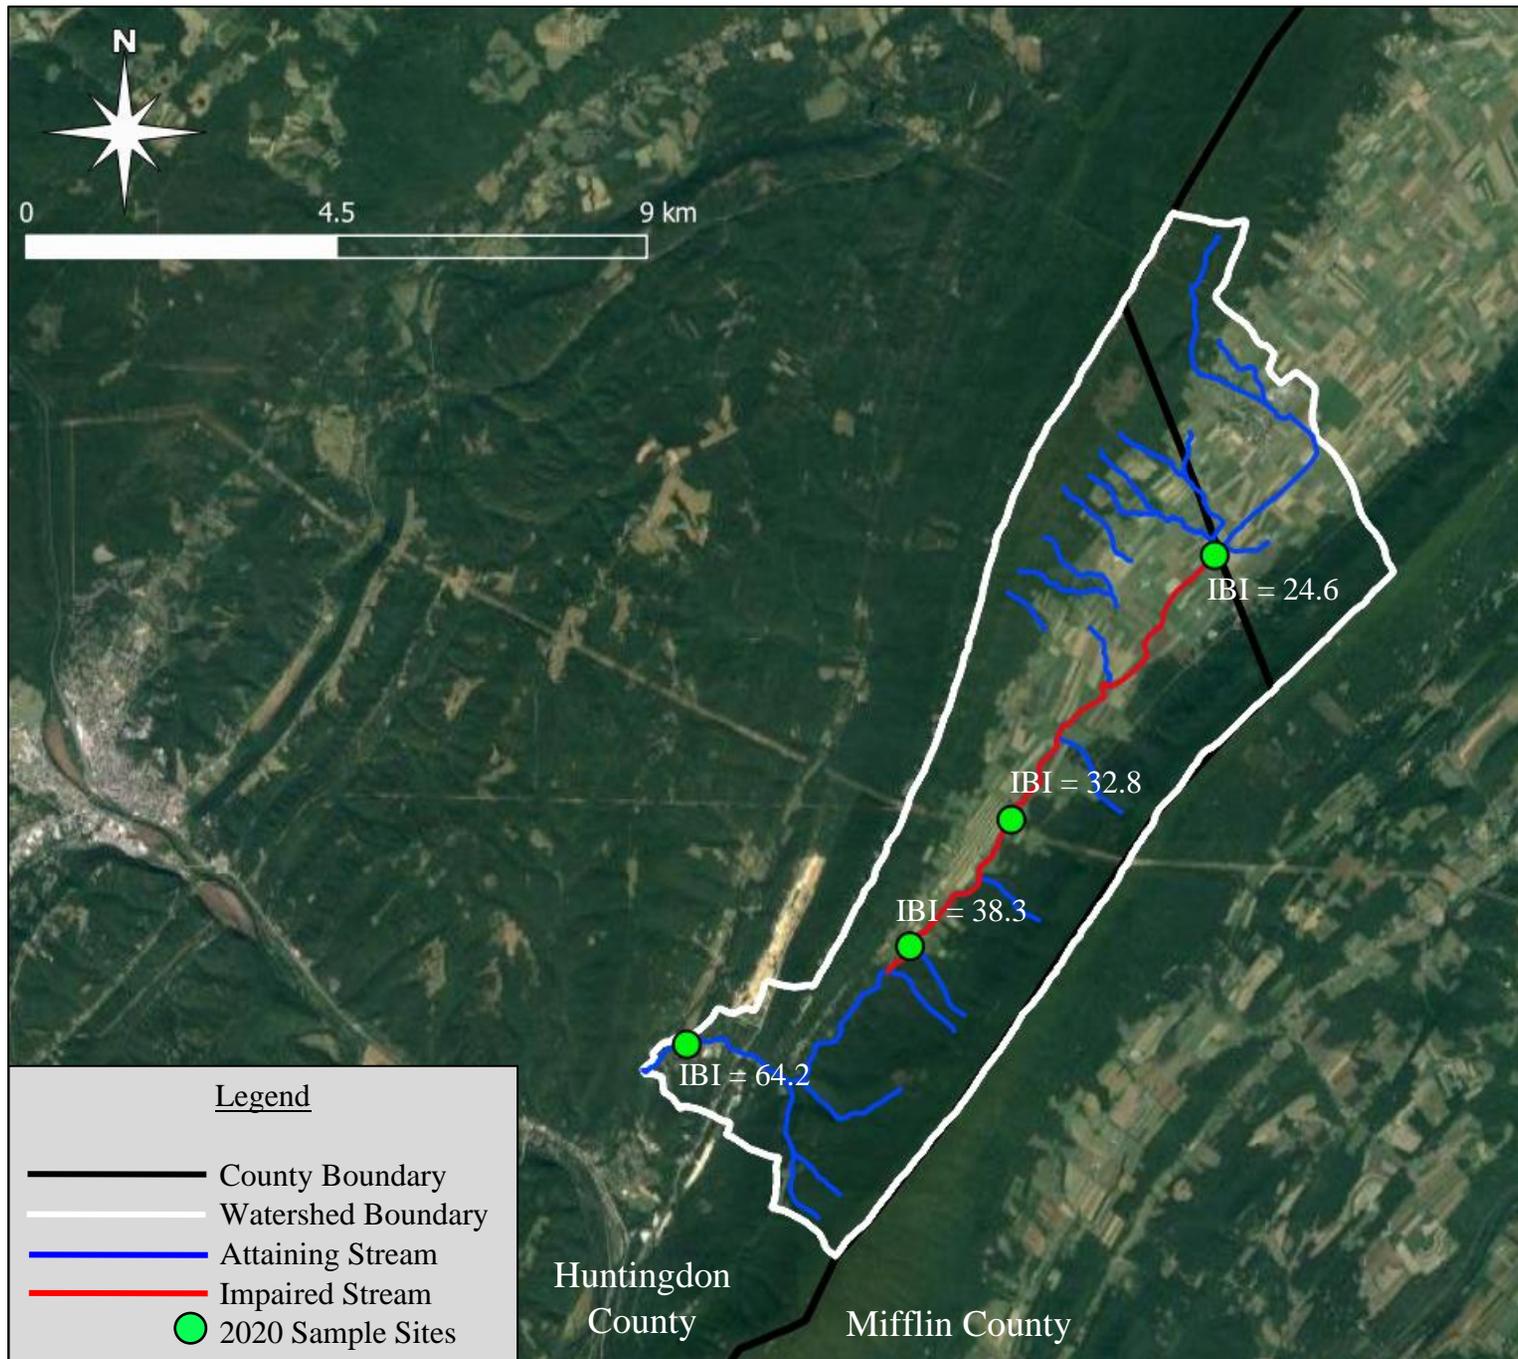
Figure 2. Map of sample sites with corresponding IBI metric scores.

A summary of index of biological integrity (IBI) metrics for each study site is provided in Table 6. In Pennsylvania, PADEP utilizes IBI assessments to determine whether a stream is “attaining” (meets water quality standards) or “impaired” (fails to meet water quality standards). For TSF streams, the PADEP impairment threshold is an IBI score less than 50 for samples collected between November-May (Shull and Pulket 2018). In 2020, all three sites along the impaired reach scored below this threshold, while the downstream site on the attaining section scored above this impairment threshold. The 2020 biological assessments followed wadeable, freestone riffle-run stream assessment methods.

There was a noticeable lack in abundance of pollution-intolerant taxa, such as mayflies, stoneflies, and caddisflies, and a noticeable abundance of “pollution-tolerant” taxa, such as midges and beetles, as we moved upstream from the attaining to the impaired stream sections. IBI metrics for the three sites along the impaired reach fell below the impairment threshold for TSF streams, while the downstream site along the attaining reach scored above the impairment threshold.
